Catheter-associated thrombosis may occur spontaneously or from a prothrombotic state associated with an underlying malignancy or treatment. The association between cancer and thrombosis arises as a consequence of cancer treatment and direct vessel trauma, which is a result of long-term central venous catheter placement.[6]

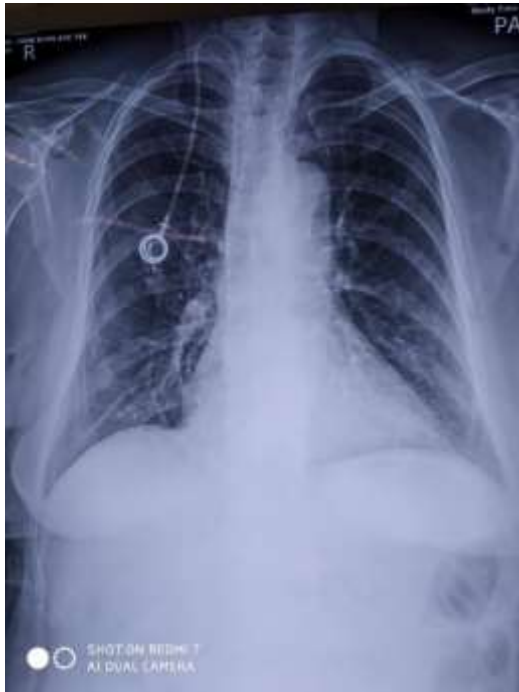
Figure (1) chemo-port site shown in chest X-ray

Position of catheter was checked with chest X-ray. (Figure 1)

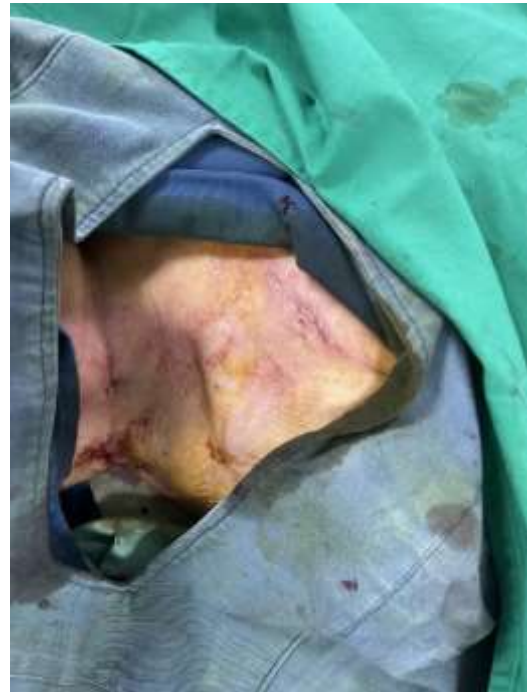
Figure (2) Post-op photo of chemo-port insertion

A separate incision of size approximately 3 cm was made on the chest wall at the level of 2nd rib. A subcutaneous pocket was made for chemo-port chamber, and catheter brought out in this wound with the help of a tunneller. The length of the catheter was measured at 0.5 cm below the sterno-manubrial joint. The catheter was attached with the chemo-port and checked the backflow. Heparinized saline was used to flush the port and catheter. The skin was sutured back. (Figure 2)

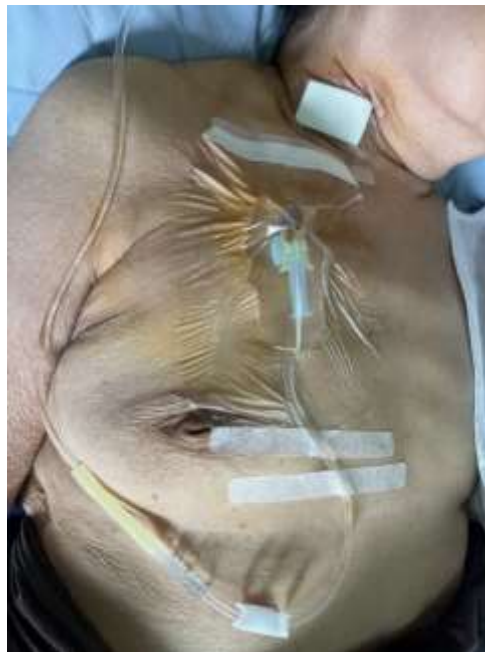
Figure (3) Huber needle inserted

Huber's needle was put seven days after insertion. (Figure 3) Total parenteral nutrition and injections were given via the chemo-port.

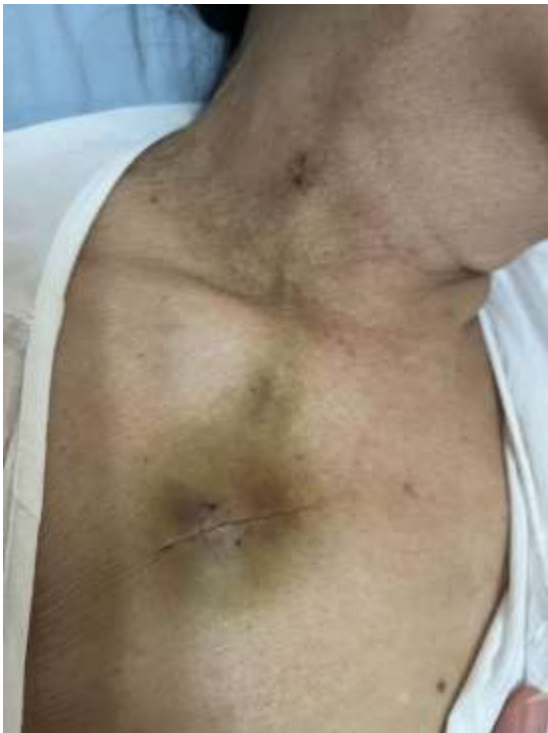
Figure (4) Post-op two weeks of chemo-port

There were no serious complications in the post-op period. (Figure 4)

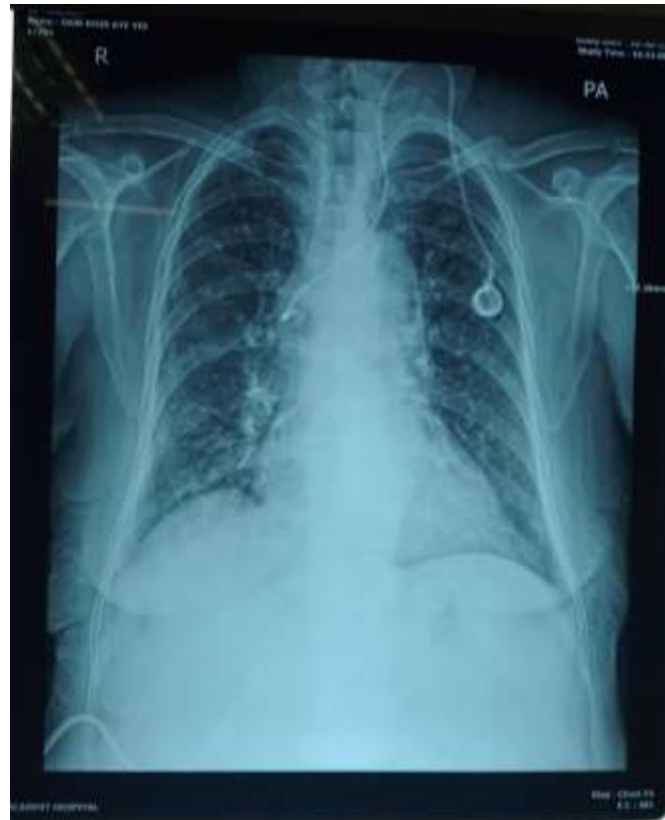
Figure (5) Chemo-port inserted on left side

Another chemo-port was inserted on left side and the old one was removed. (Figure 5)

The patient received nutrition via the chemo-port and her well-being improved. One month later she accidentally injured the site of chemo-port and haematoma occurred. The chemo-port needed removal and another chemo-port was inserted on left side. (Figure 5)
