Case Report: Removal of a Fractured Nickel-Titanium Instrument from a Left Lower Molar.

This case report details the successful removal of a fractured nickel-titanium (NiTi) endodontic instrument from the root canal of a left lower molar in a 30-year-old female patient. The patient presented with mild, intermittent paresthesia in the lower lip, which intensified in the morning. This report highlights the challenges associated with the procedure and the use of an operating microscope for enhanced visualization.

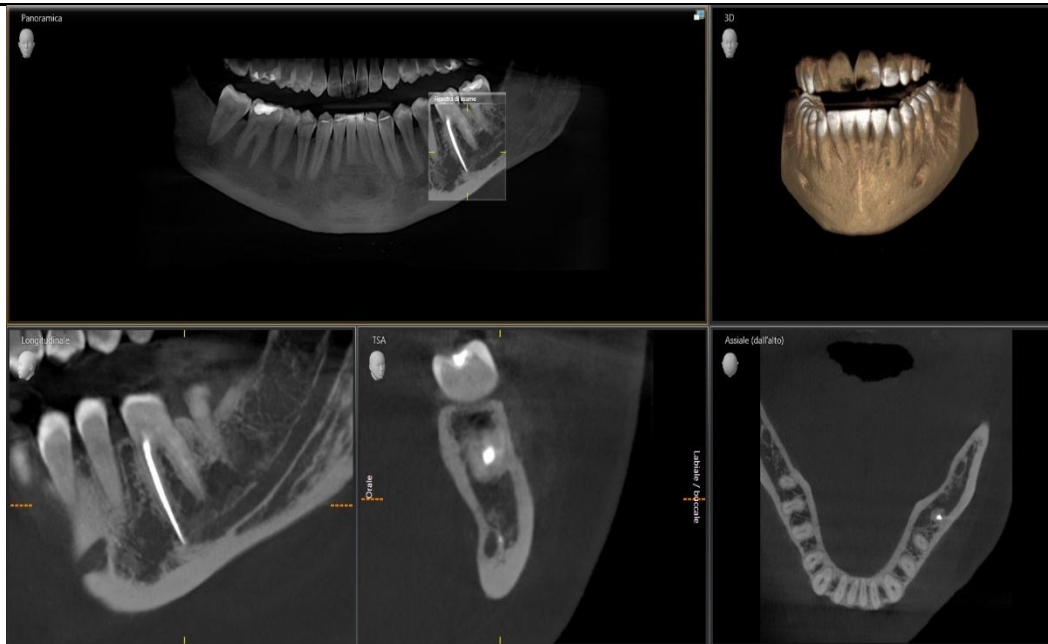
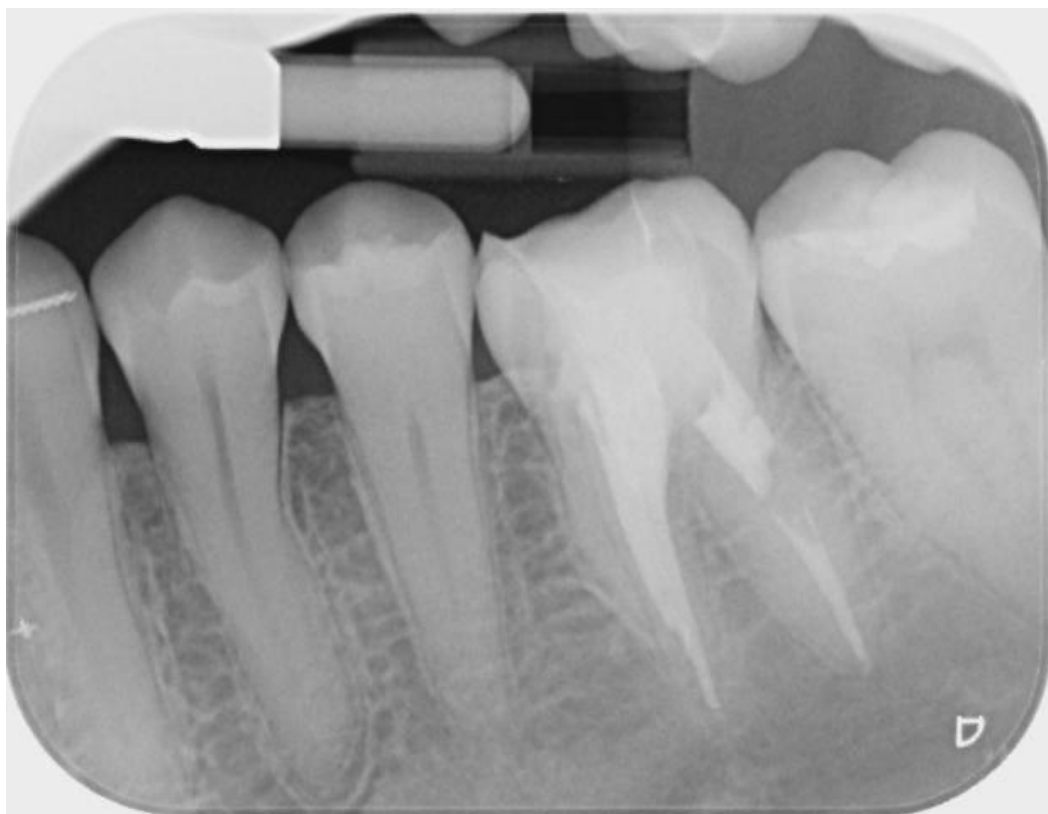
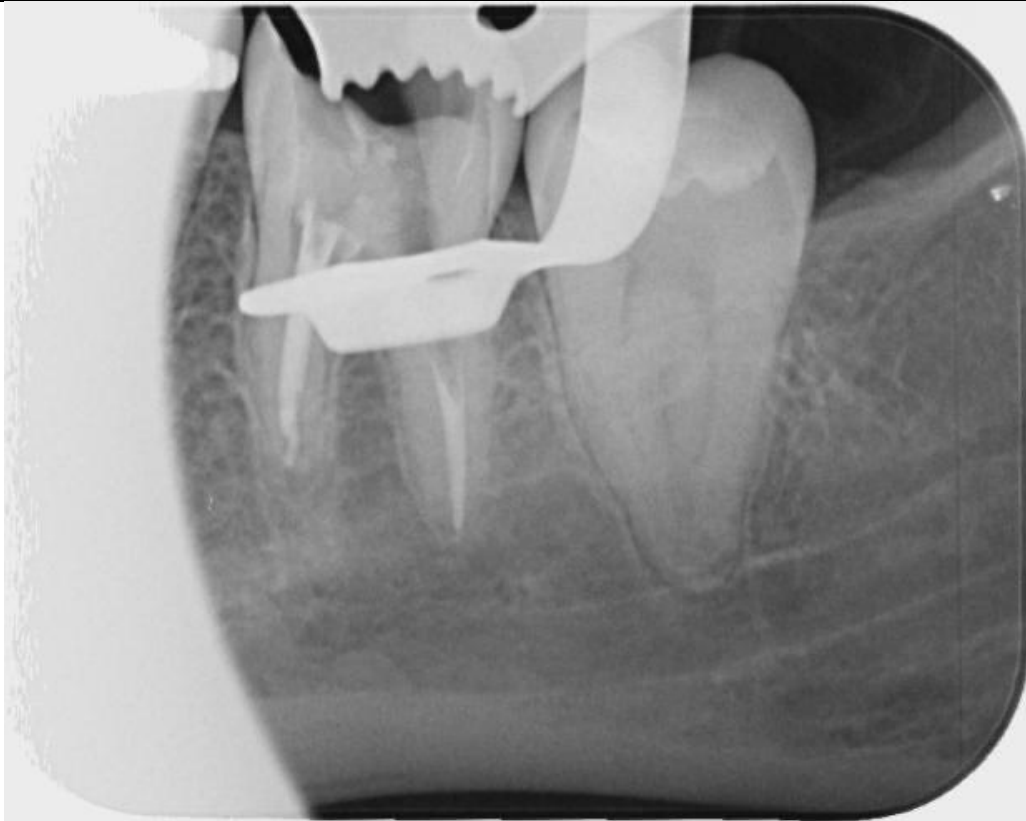
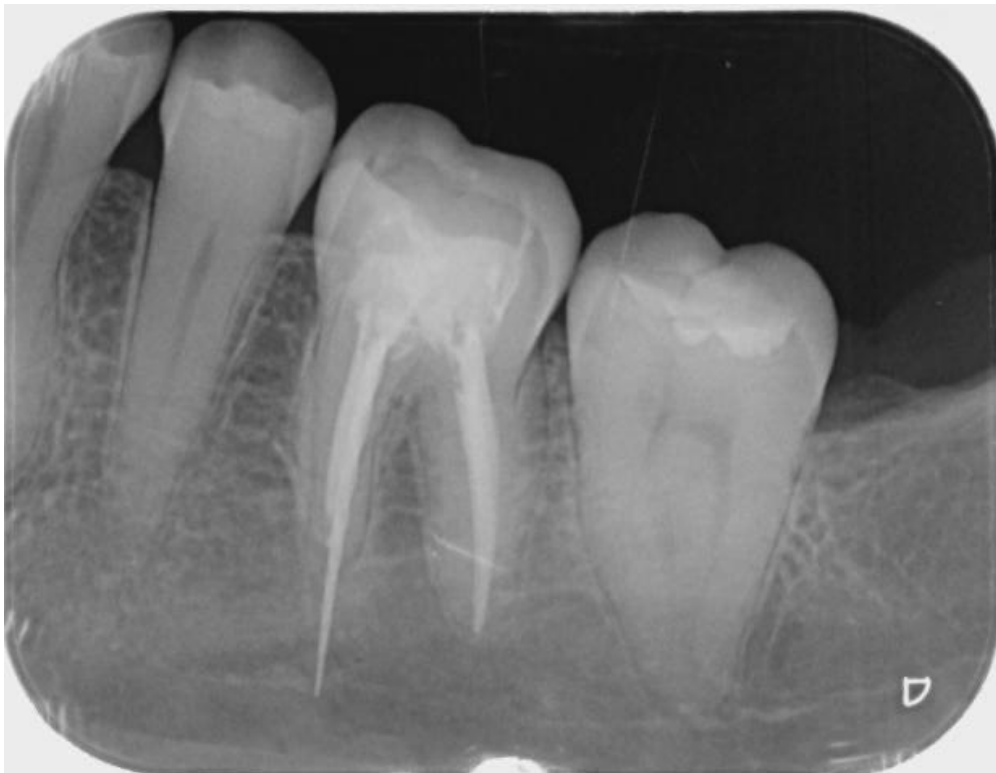
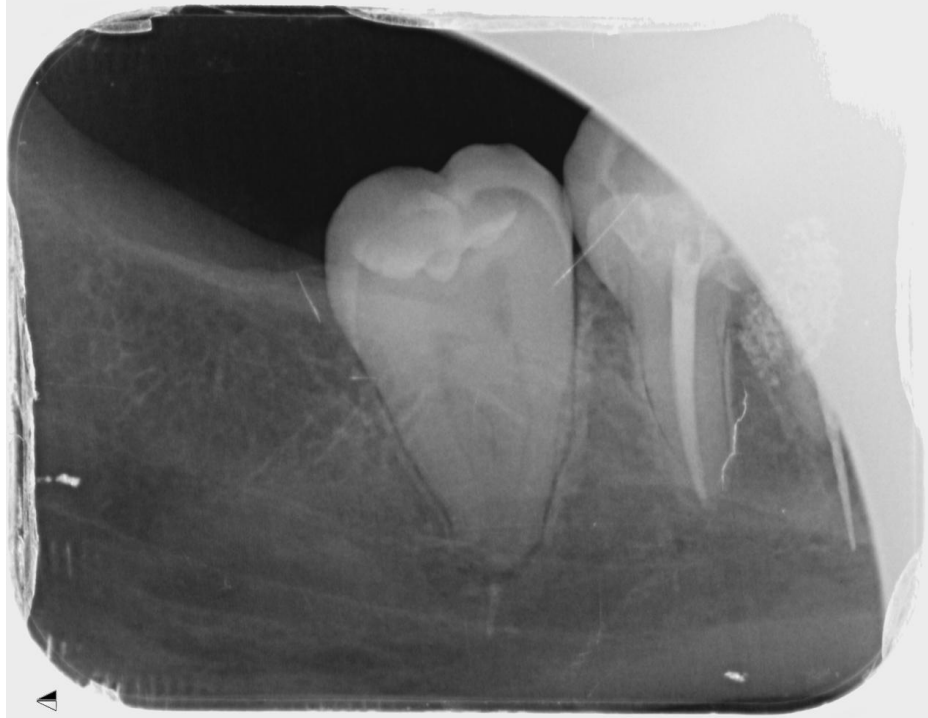
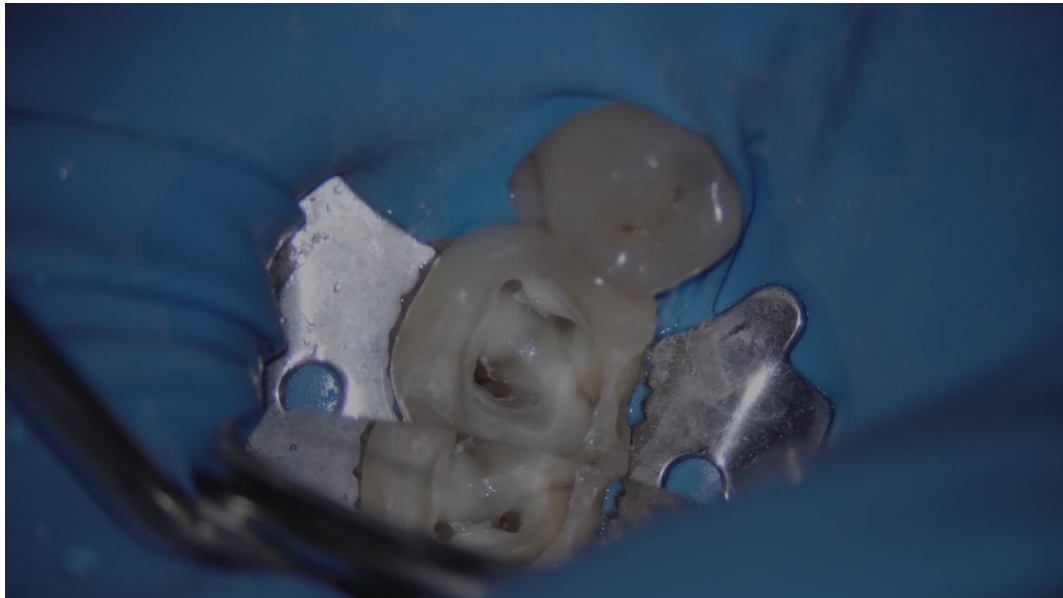
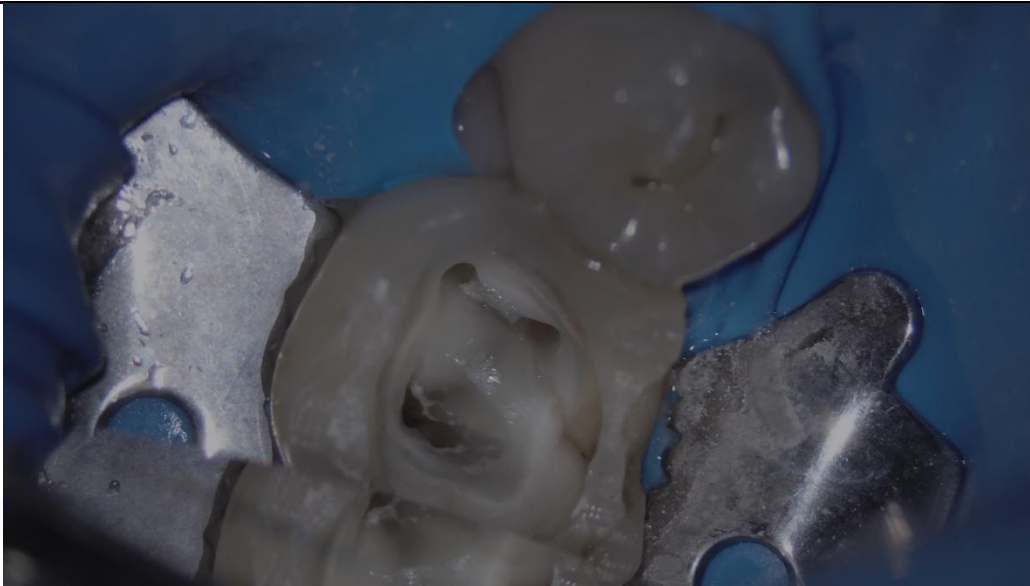
To assess the extent of the fracture and plan for removal, we obtained periapical radiographs and a cone-beam computed tomography (CBCT) scan. The imaging revealed the fractured NiTi instrument lodged deep within the canal system, complicating its retrieval due to its position approximately 8 mm beyond the apical foramen.

A rubber dam was placed to isolate the tooth, and the access cavity was refined to facilitate our approach to the fractured instrument. Using ultrasonic tips designed for endodontic retrieval, we carefully navigated the canal to engage the fractured piece.

Despite the challenging anatomy and the depth of the fracture, we successfully retrieved the instrument without any complications. The use of the microscope was invaluable in providing a clear view of the canal system and the surrounding structures.

The patient was prescribed analgesics and instructed on postoperative care. A follow-up appointment was scheduled for one week later, during which she reported a significant reduction in paresthesia and overall discomfort. Radiographic evaluation confirmed the successful retrieval of the fractured instrument and the integrity of the root structure.
