Mechanical Failure and Complications Following TFNA Fixation in a Comminuted Intertrochanteric Femur Fracture

Dr Saif Saeed Almehrzi*

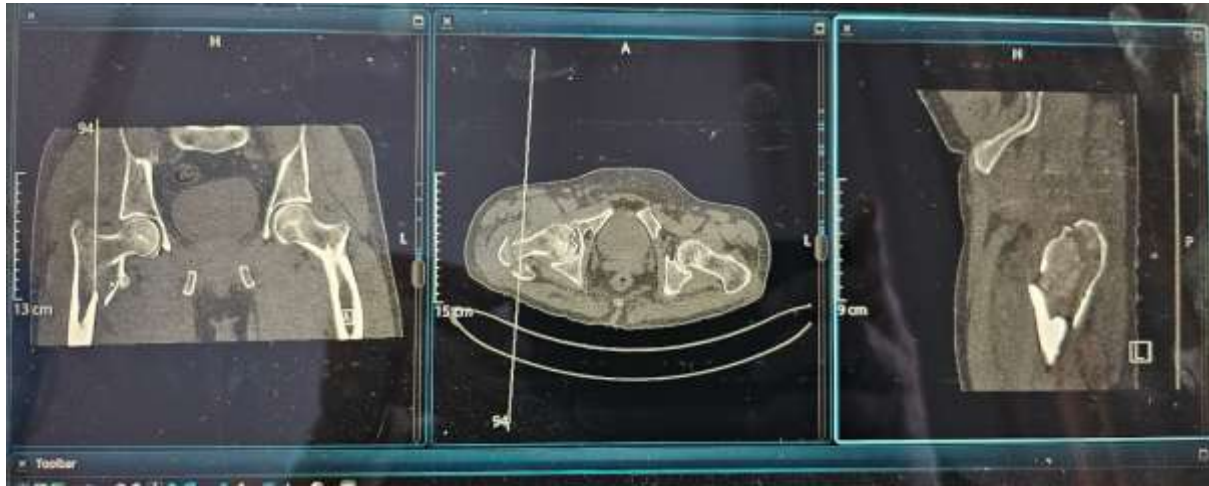
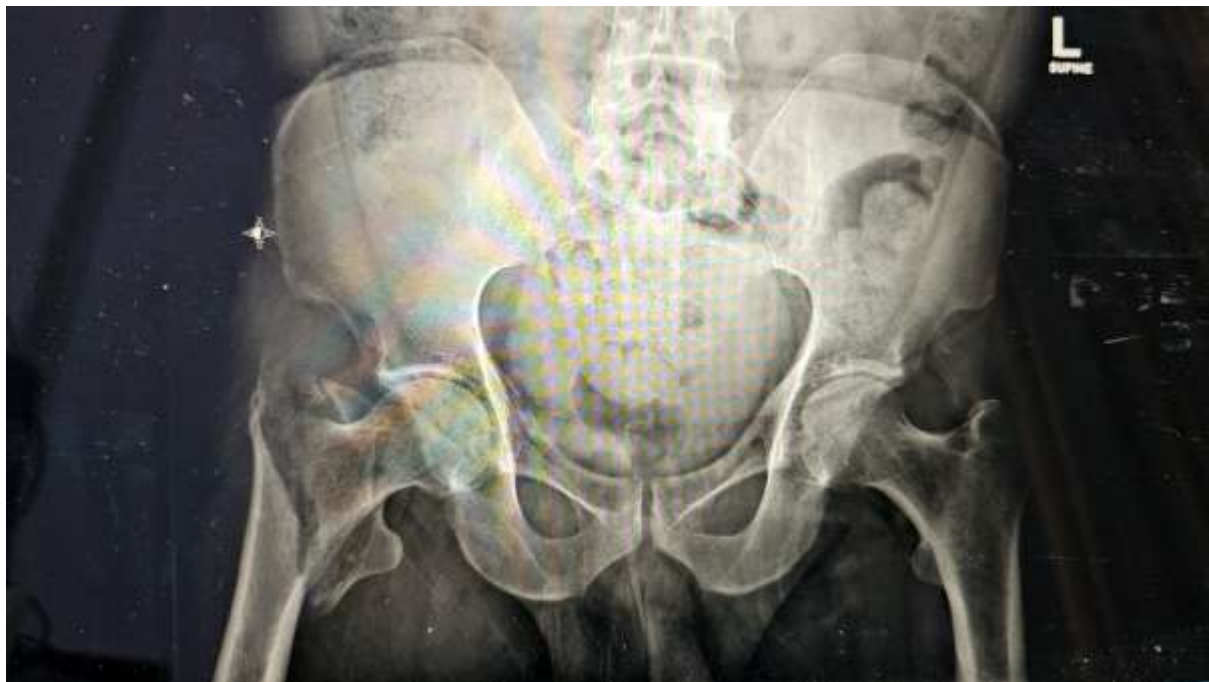
The patient, a 75-year-old female, presented to the emergency department following a fall at home. Radiographic evaluation revealed a comminuted intertrochanteric femur fracture on the right side. The patient was admitted for surgical management after appropriate medical and anesthetic clearance.

Post fall xray :

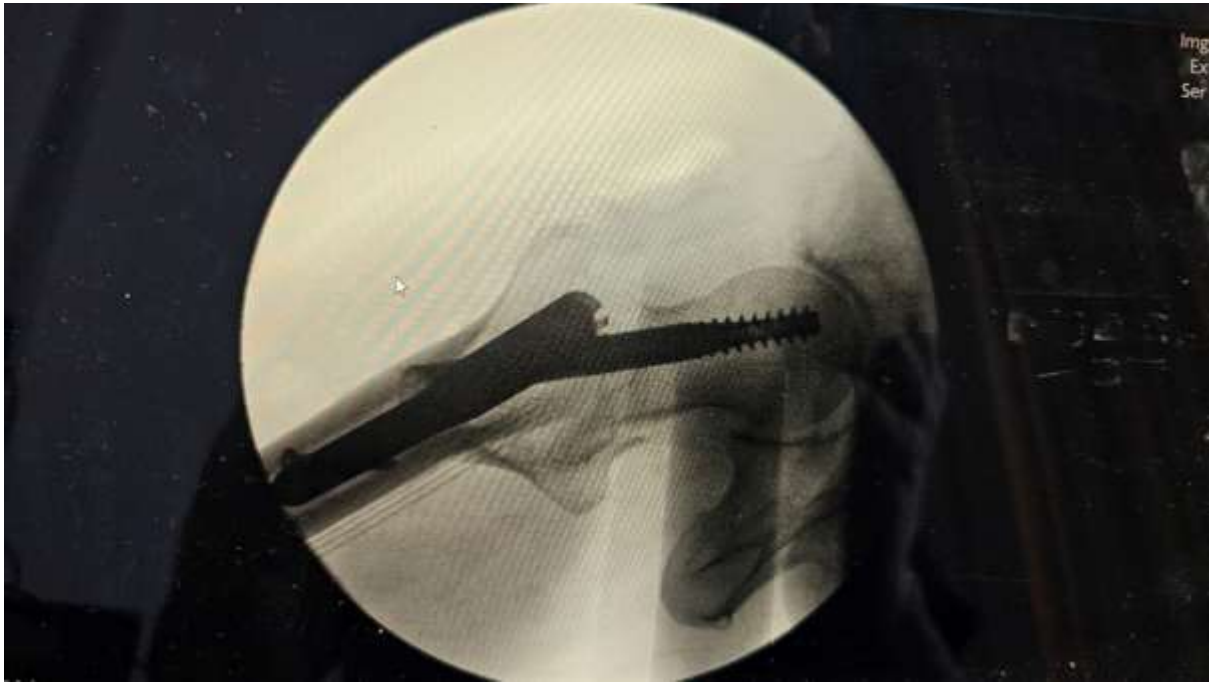
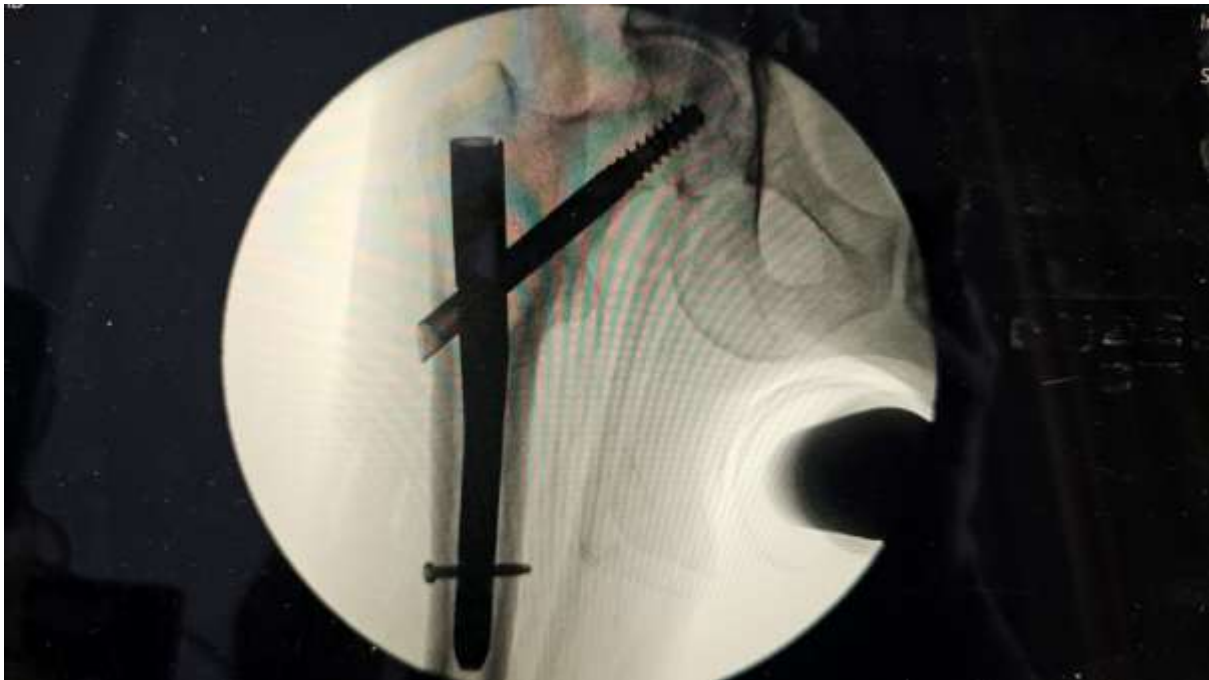
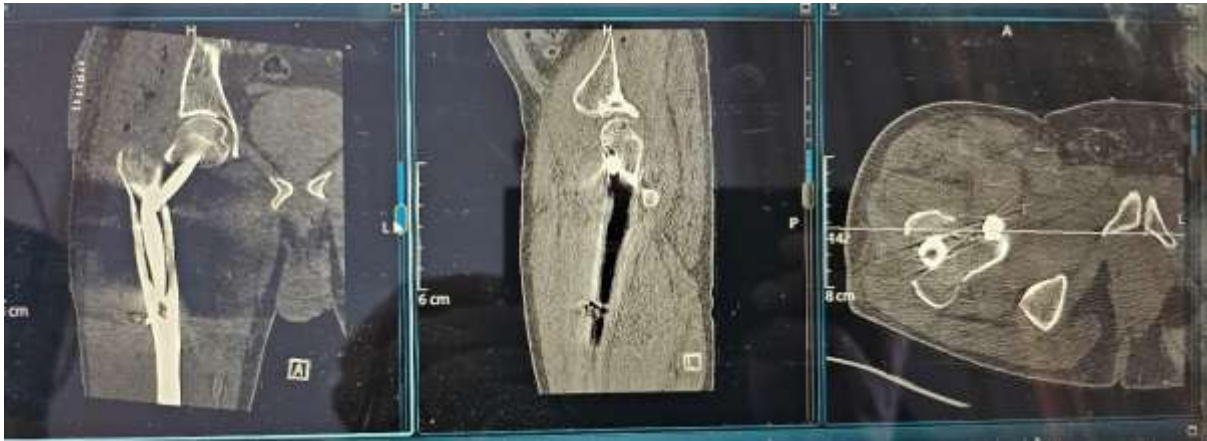
The patient underwent internal fixation using a Trochanteric Fixation Nail Advanced (TFNA). Intraoperatively, fracture reduction was suboptimal, with mild varus malalignment. The entry point for the nail was slightly lateral, and the cephalic screw was inserted in an inferior-anterior position. Intraoperative fluoroscopy showed acceptable placement, although the exact position of the screw could not be fully assessed.

Postoperative X-rays were inconclusive due to suboptimal views. To evaluate screw position and fracture alignment more accurately, a CT scan was performed. The CT revealed that the cephalic screw had cut through the femoral neck, protruding medially outside the cortex, and continued into the femoral head—confirming a case of cut-through.

Post first surgery :

The case was reviewed in a multidisciplinary orthopedic surgery meeting. Given the evidence of mechanical failure, the decision was made to proceed with revision surgery.

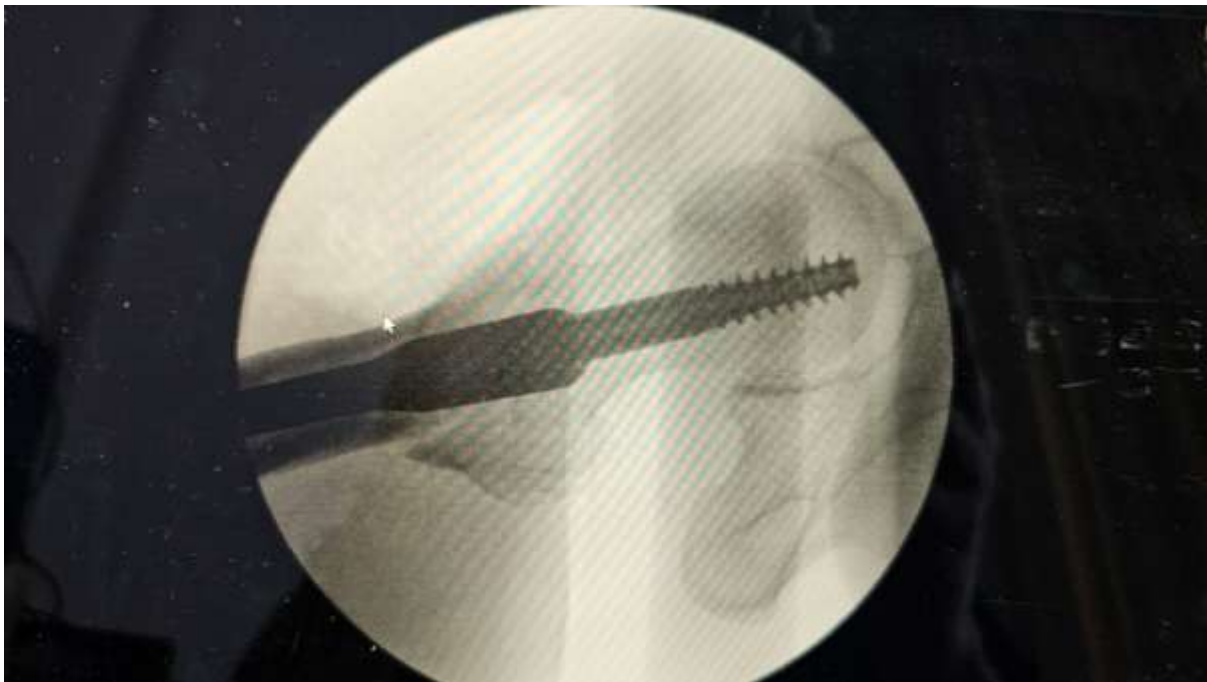
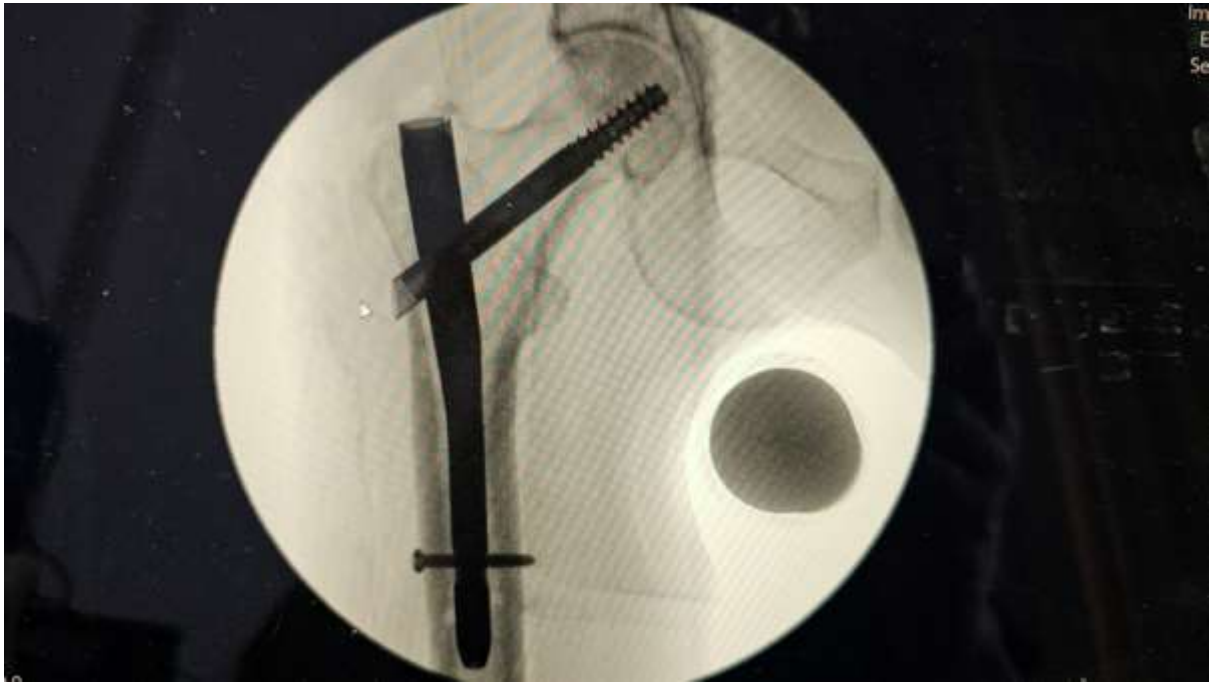
Revision surgery :

Anatomical fracture reduction

Use of a medial-posterior nail entry point

Placement of the cephalic screw in a central–central position within the femoral head to optimize mechanical stability
