## Case Study

### **Malposition of the ventricular pacing lead in the left ventricle**

1,2,3,4. Department of Cardiology, General Hospital of Chalkida, October 2020.

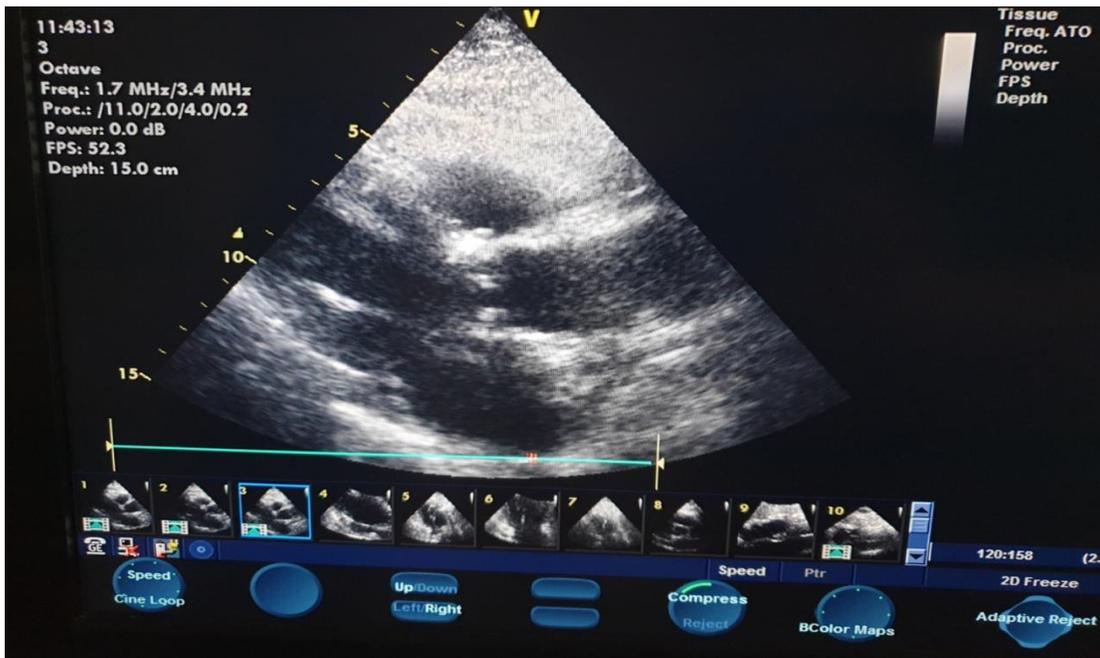
**Figure 2:** Transthoracic Ultrasound images- Long axis view

The patient proceeded to an appointment in our hospital office after his physician urged him for additional consultation. We performed a transthoracic heart ultrasound and found that the ventricular lead passed from the right atrium, threw the atrial septal into the left atrium and threw the mitral valve into the left ventricle anchoring on the posterior wall.

Afterward, the patient was admitted to the department that undertook the original implantation and a second session took place, in which the ventricular lead was removed from the left ventricle and relocated to the right ventricle, as it was originally planned without any further complications.

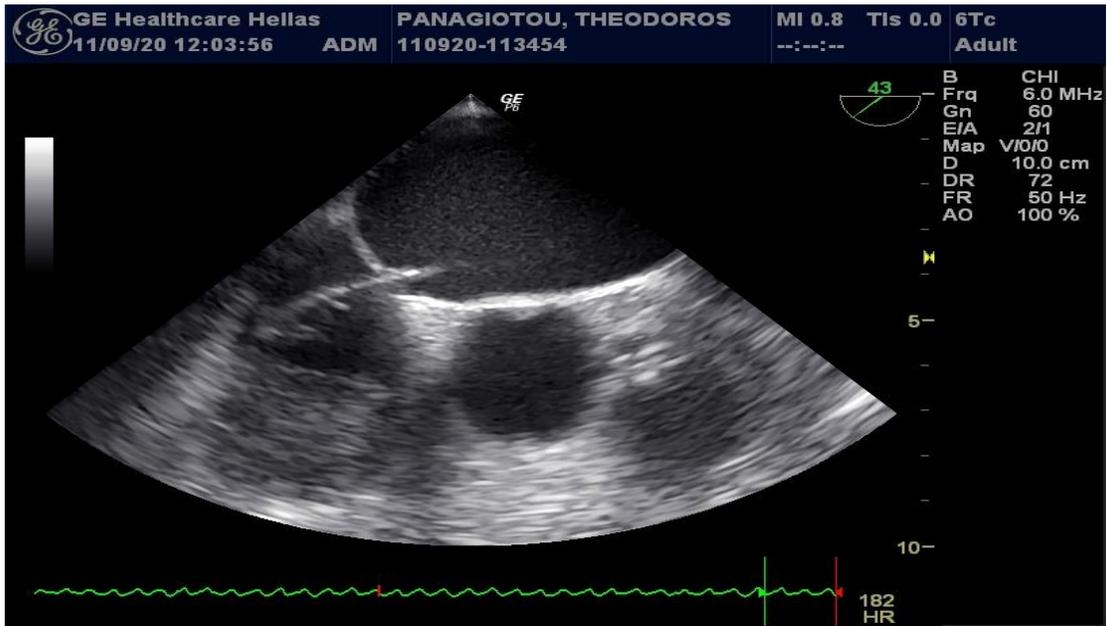
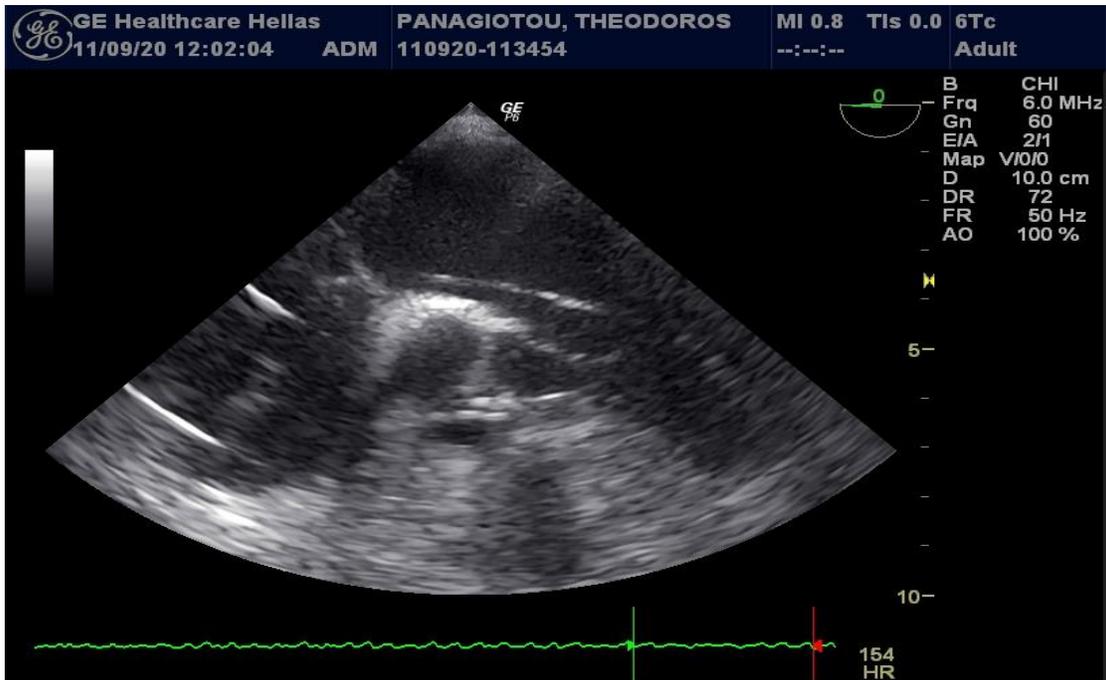
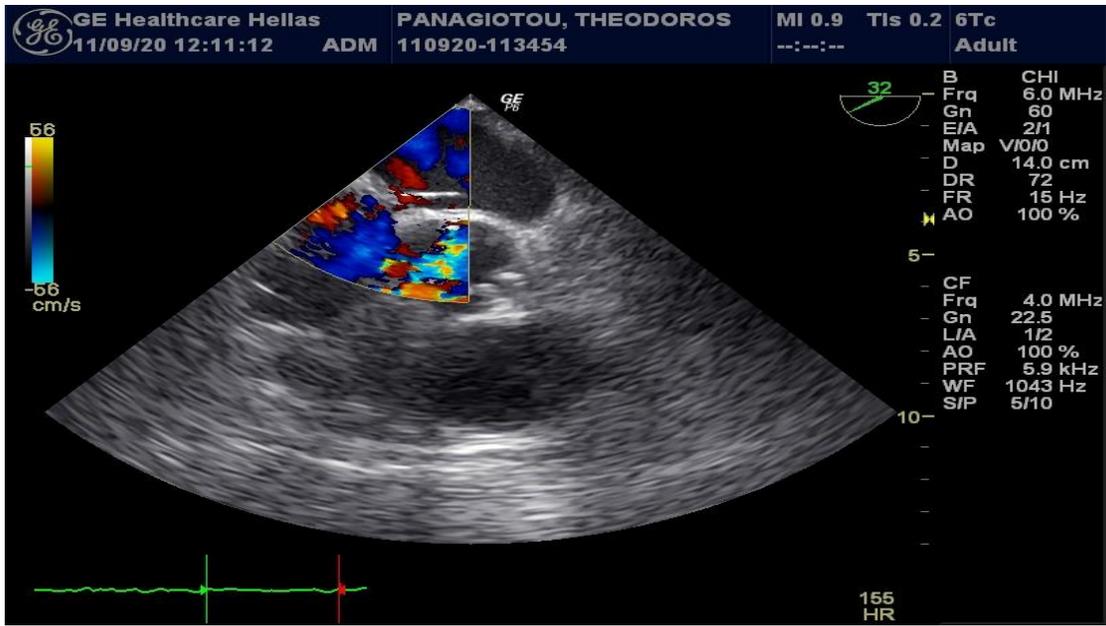
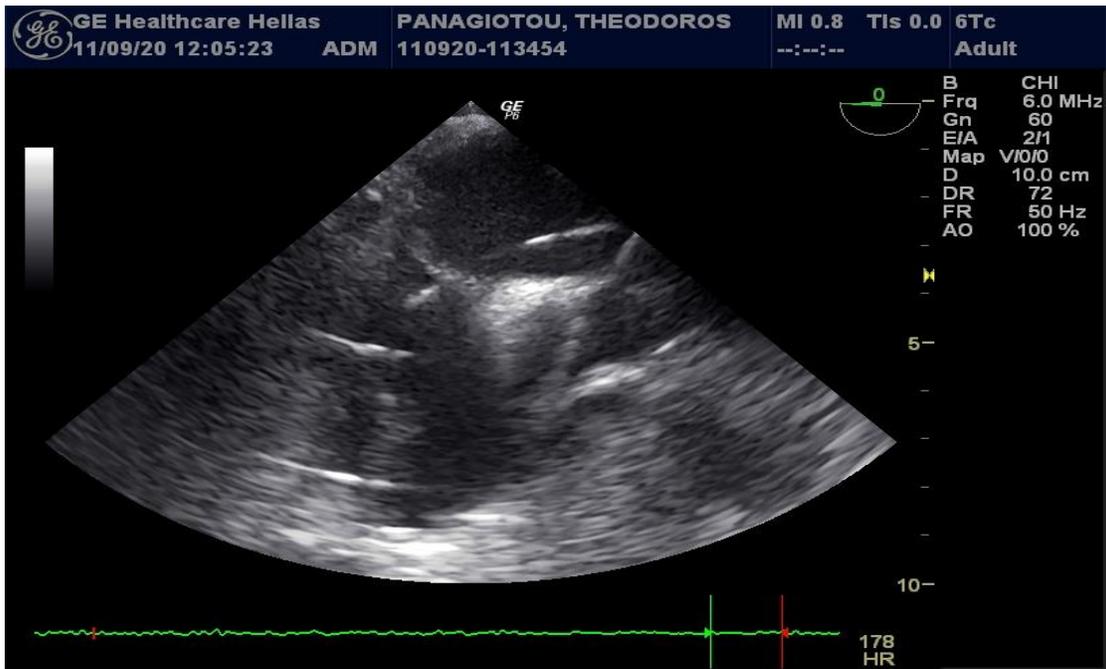
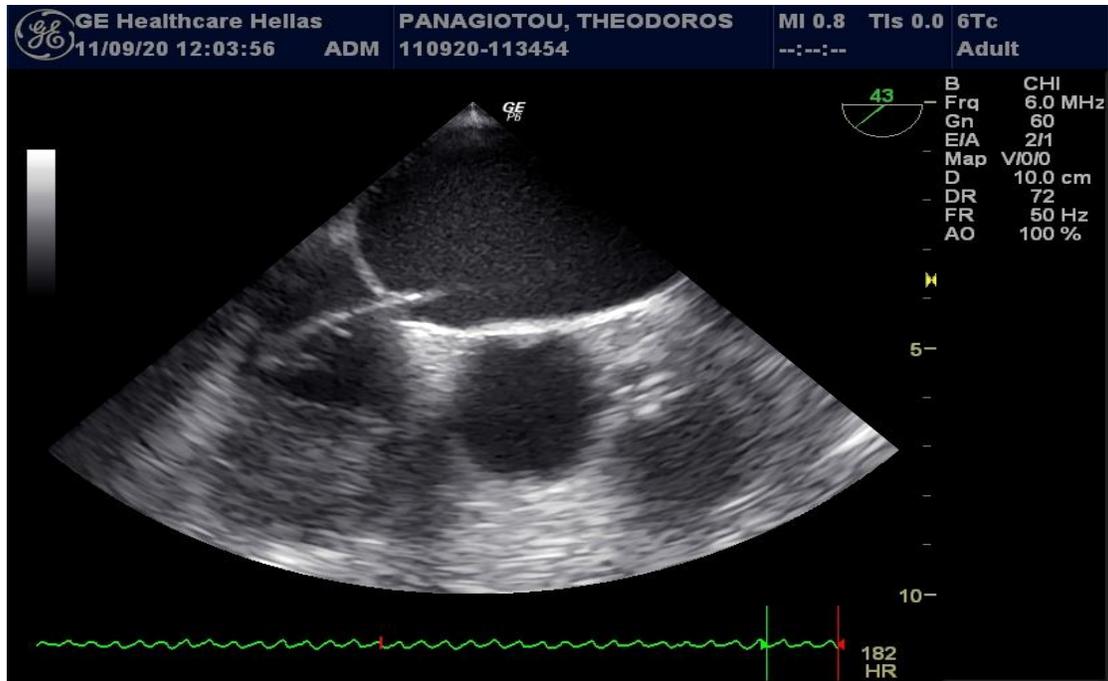
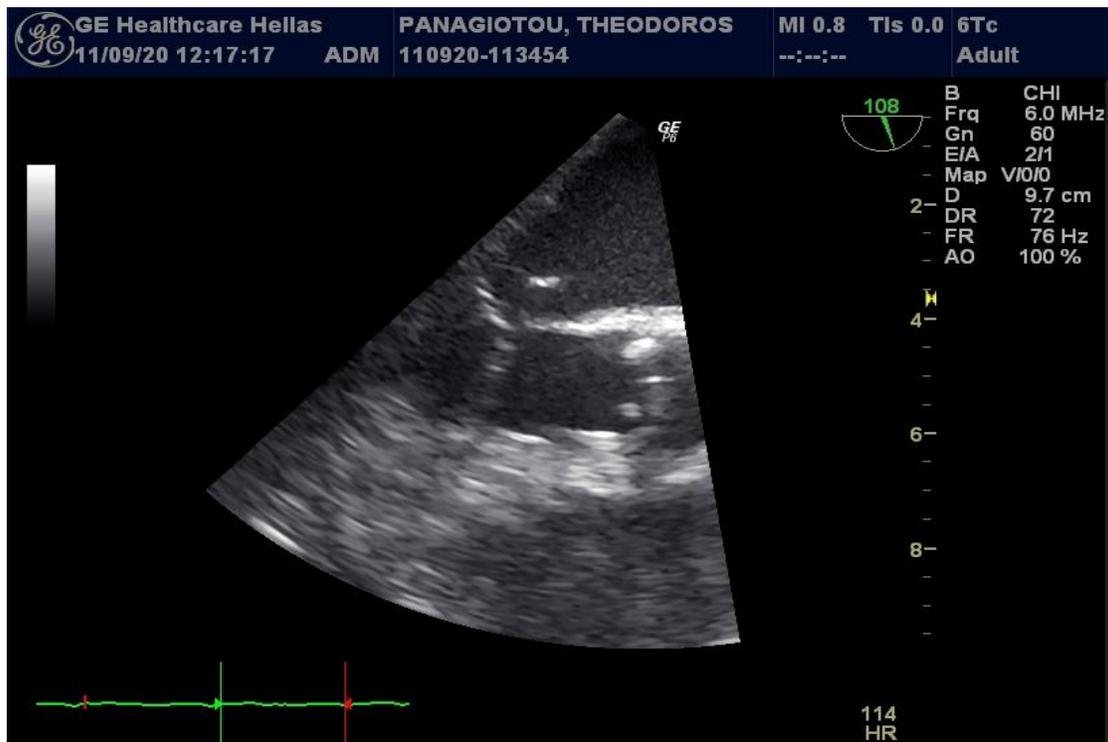
Transesophageal views

The next day the patient underwent a transesophageal ultrasound from which we confirmed the initial findings.
